# Summary Inspection Report

**5630 Moraga Ave. Oakland Ca 94708**

**Inspection Date:** 3/14/2016

**Report Number:** 9985(S)

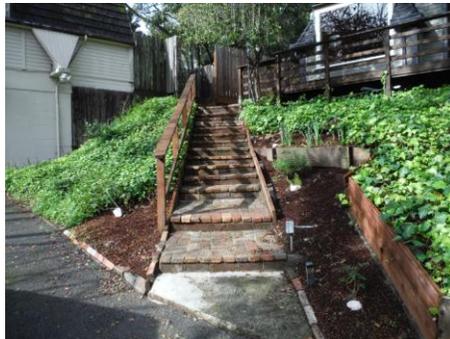
- **Safety Issue:** The front brick steps are uneven in rise and have some displacement (and tilting) towards the top which could pose a trip issue. Also, the flat top handrails are not considered graspable and are too high according to modern safety standards. We recommend upgrading to modern standards.

Front steps not even/railings wrong

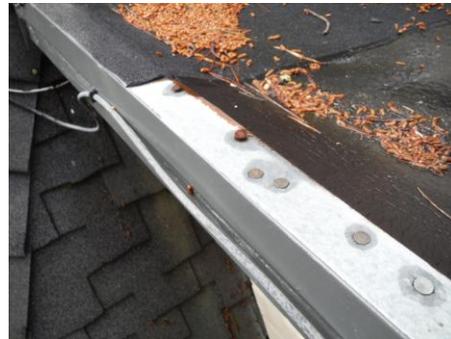
- **Repair:** There were exposed nail heads on the edge flashings. This flashing edge is usually finished off with a layer on top, however the front was missing this coveing. If nails are used to tie down flashing, the heads should be sealed to prevent water penetration. Recommend repair.

Roof edging not finished/exposed nails

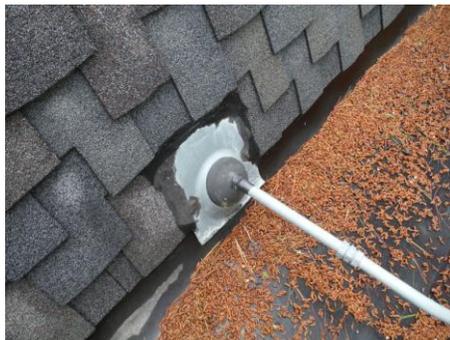
Improper flashing

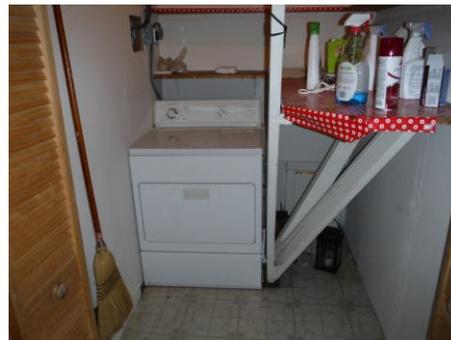
- **Repair:** There were no laundry hook-ups observed. Recommend adding.
- **Monitor:** The floor is sloping to the L. Sloping floors can be common in older homes due to settlement. Recommend evaluation by a qualified contractor as desired.

No washer hook-ups for laundry area

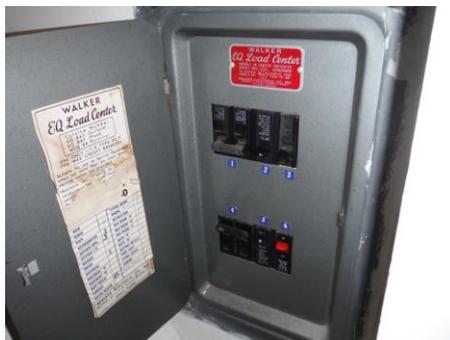
- **Repair:** The sub panel is an older/outdated. There are concerns that panels of this type and other discontinued brands may not operate safely in some conditions. The installation of a new panel may be the only way to eliminate potential risks associated with outdated panels. We recommend this sub panel be replaced with a modern circuit breaker panel.

Outdated panel in bathroom

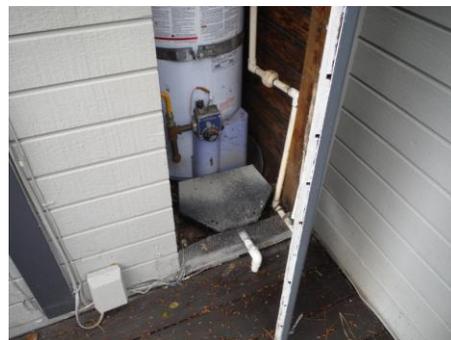
TPRV extension wrong material/termination
